Case Study

Energy is Expensive to Start With!

Border Express Underwood

Double-counting results in a refund of over \$160,000 within one financial year.

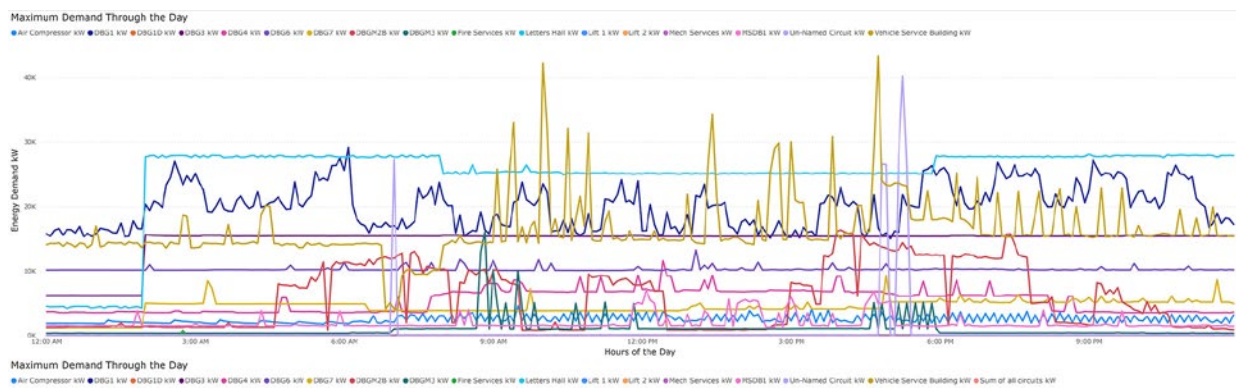
Above: Source data from each of the sub meters - interesting but something still didn't add up.

The results were compelling and clear. The submeters created a usage pattern identical to the site's retail meter, but at much lower values. Ecovantage's report was sent to the energy retailer and triggered a formal inhouse review of the sites metering calibration and topography.

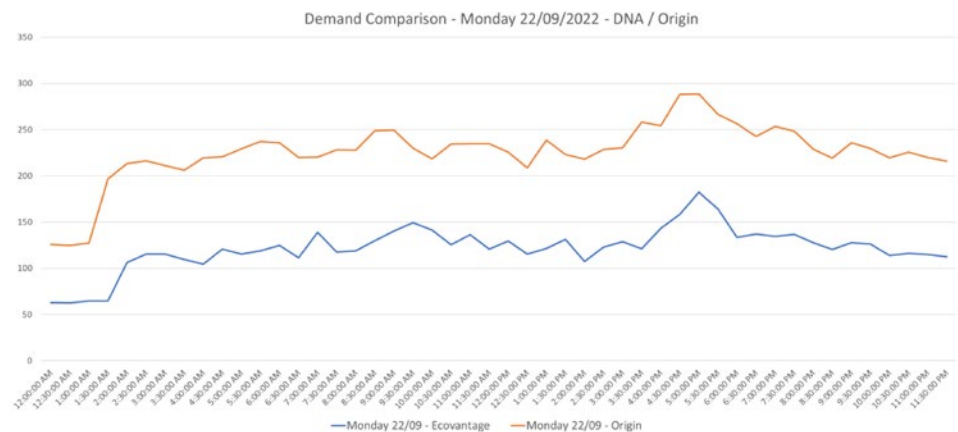
Right: The blue line shows the total consumption on site. The orange line is the meter reading from the retailer, which was close to double the consumption. The gap is the over charged amount.

It was found that the sites check meter* was being read as a consumption meter - in essence double counting the energy consumed from one of the site's two High Voltage supplies.

This resulted in a refund of \$164,000 based on the usage over a single financial year. Retrospective claims may be pursued as well.
